**REPORT OF INVESTIGATION**

**Surface Metal Mine  
(Copper Ore)**

**Fatal Machinery Accident  
December 5, 2004**

**Robinson Nevada Mining Company  
Robinson Operation  
Ruth, White Pine County, Nevada  
Mine I.D. No. 26-01916**

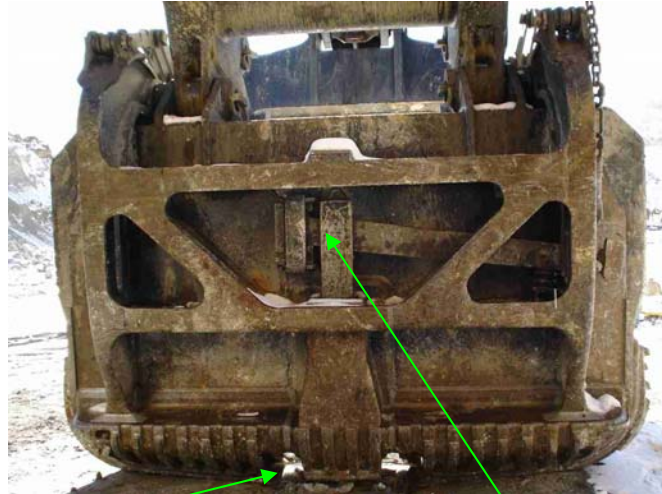
On the day of the accident, Michael Squire and Gary Blackham, (victims) reported to work at 5:00 a.m., their normal starting time. About 6:30 a.m., Gerald Jordt, maintenance foreman, received a call from Leadford Hall, shovel operator. Hall stated that the latch bar on the dipper door was not working properly. Apparently, the bolts securing the latching mechanism insert loosened, causing the latch bar to malfunction.

Dutchman Picture #1 Latch Bar

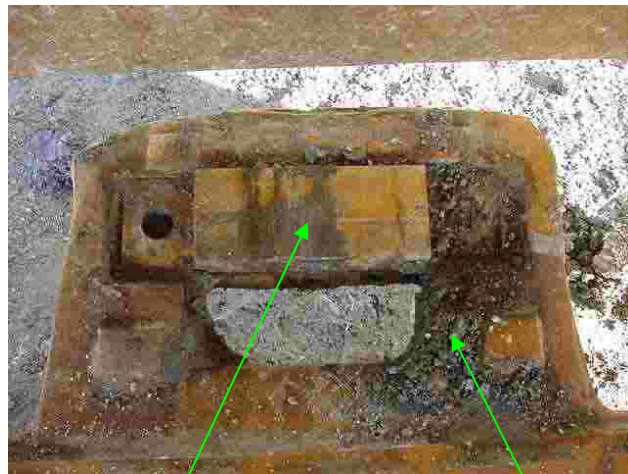
Squire had just finished his assigned job and joined the repair crew. While standing between the dipper door and the dipper, Blackham cut the head of the bolts off and Squire drove the bolts out of the insert. Jordt and Robinson were also standing inside the door helping Squire and Blackham remove the bolts. Jordt told Robinson to step up inside of the dipper to work on one of the bolts. Jordt then turned and walked out between the door and the dipper to converse with Hall.

Dutchman Insert Picture #2 Dutchman
